USAAEFA PROJECT NO. 77-17

AIRWORTHINESS AND FLIGHT CHARACTERISTICS EVALUATION UH-60A (BLACK HAWK) HELICOPTER

FINAL REPORT

SEPTEMBER 1981

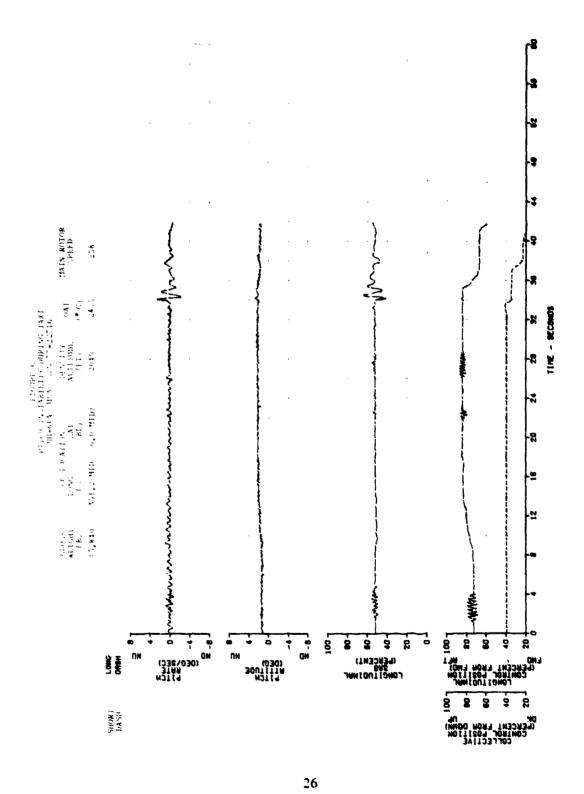
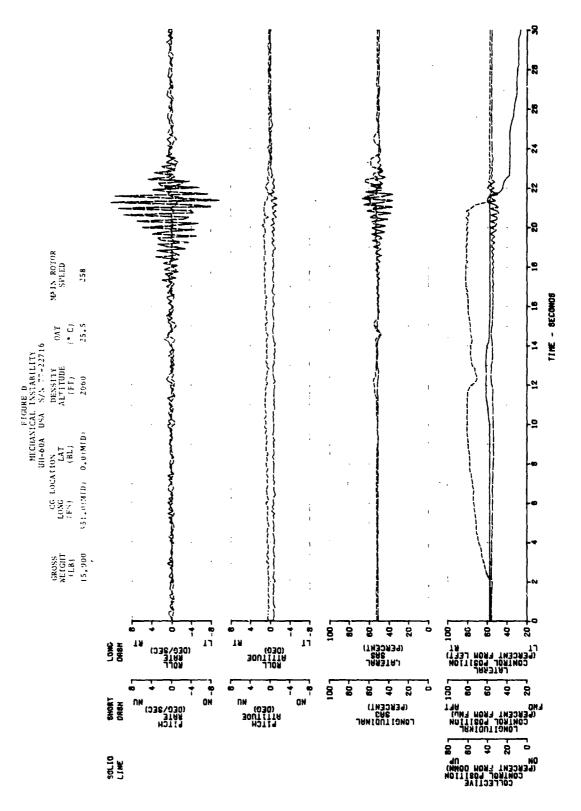
- 60. During ground handling evaluations the UH-60A exhibited a divergent mechanical instability (fig. D). The instability occurred when the collective control was increased to the point where the aircraft was "light" on its wheels (collective greater than 30 percent), the longitudinal cyclic placed in an aft position (greater then 75 percent from full forward) and the wheel brakes set to prevent sircraft movement. The mechanical instability appeared to be dependent upon aircraft cg and gross weight; therefore, position of the cyclic and collective controls where initiation occurs may vary. The instability was a self excited oscillation (approx 3 Hz) and the rate at which the amplitude increased was slow enough to allow the pilot to damp the oscillation by lowering the collective or by a forward cyclic input. The mechanical instability appears only in the roll axis. The self excited divergent mechanical instability during ground operation is a shortcoming previously reported (PAE IIIA, Dec 1979). Consideration should be given to incorporating the following caution in the UH-60A operator's manual:

The UH-60A has encountered ground resonance when the following three conditions occur simultaneously:

- 1) Parking brake ON
- 2) Aircraft "light" on the wheels
- 3) Extreme aft cyclic control

The ground resonance is characterized by a lateral oscillation (approximately 3 cycles per second). During these oscillations only small attitude changes are encountered; however, roll rate will increase significantly within two seconds. The resonance can be quickly damped by reducing collective, or by bringing the aircraft to a hover, or by centering the longitudinal cyclic control.
